Failure Analysis – Missing Signals

Problem Statement:

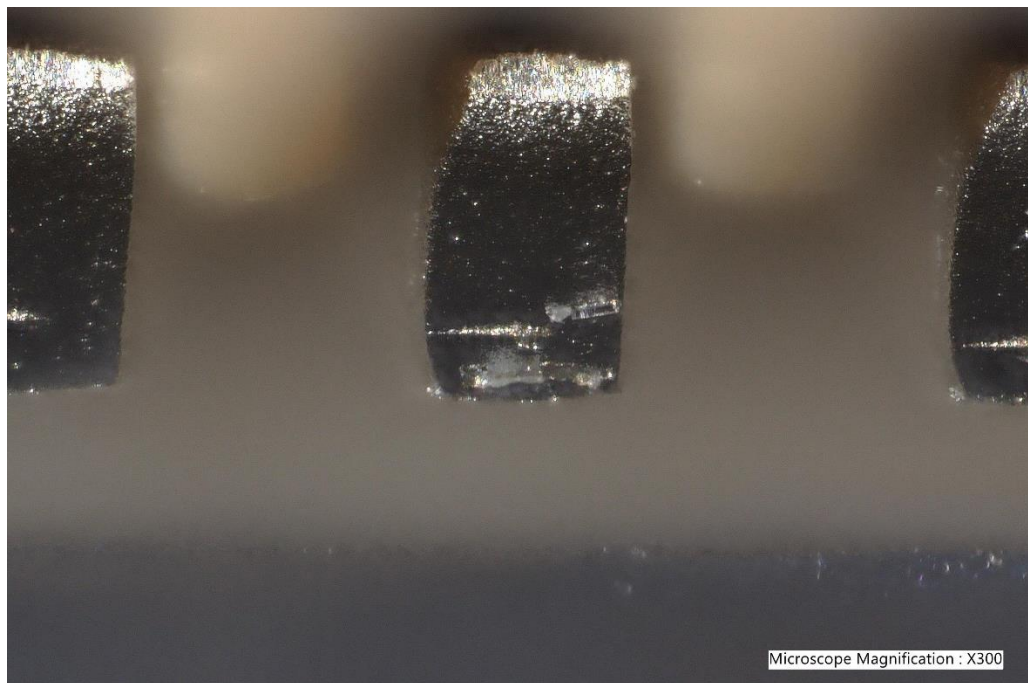
Figure 2: Visual Inspection of Connector Pins

The examination began with a detailed external visual inspection, using AAA Test Lab's high-magnification Keyence microscope. This quick step allows the team to quickly identify any glaring issues and gather clues towards where the investigation should follow next. Insertion marks were observed on the pins, leading to more detailed examination. Small regions on the pins had slightly recessed surface morphology where mechanical force of the connector pin contacting the control board had slightly removed some of the metallic surface (Figure 2). This introduced a potential source of FOD (foreign object debris) into the

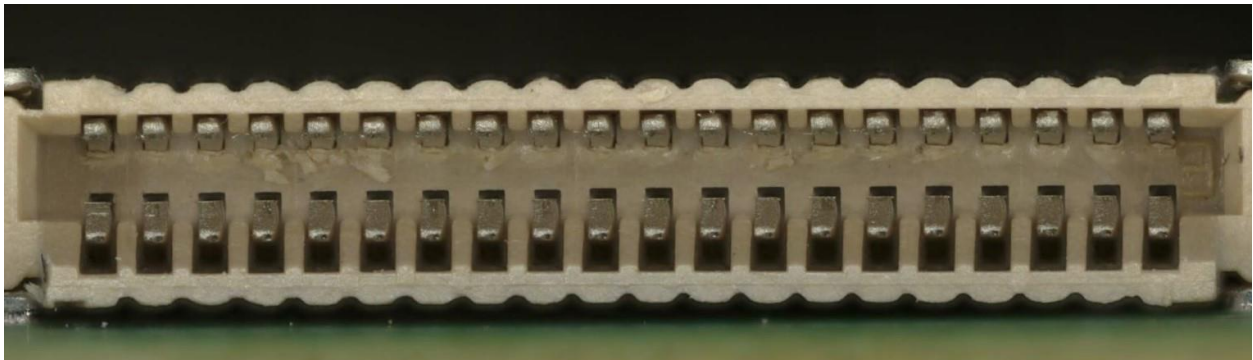
Figure 3: Connector View

Destructive analysis was allowed under this effort, so a closer look at the connectors (Figure 3) with a slow, deliberate deconstruction process was up next to circle back and look for other signs of the true failure mode. This effort was fruitful, revealing the final destination for the material that was missing from the surface of connector pins. Small metallic strands were observed between the pins of the connector, potentially originating from the tin plating on the cable itself. High magnification imaging was conducted of these strands, and it was observed that the physical attachment of the strands from pin to pin could be causing intermittent shorts, interference, or uncharacteristic system performance in general (Figure 4).

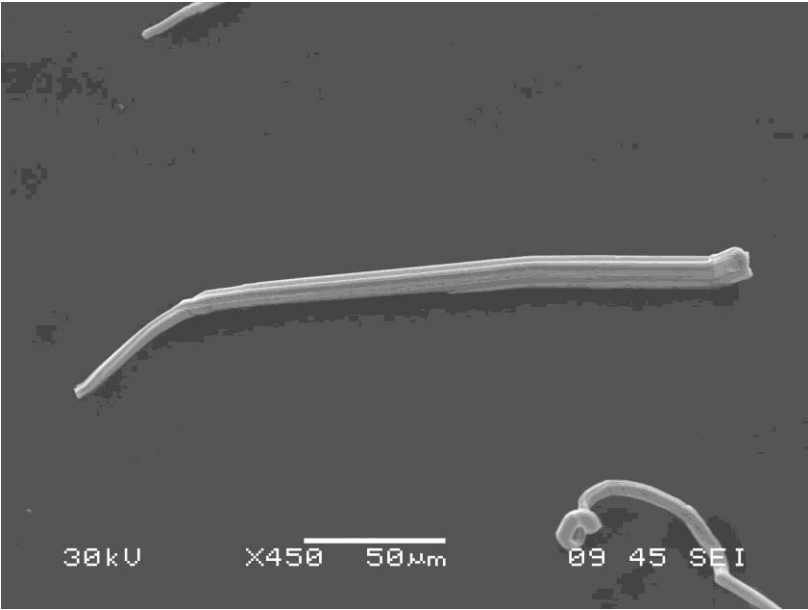
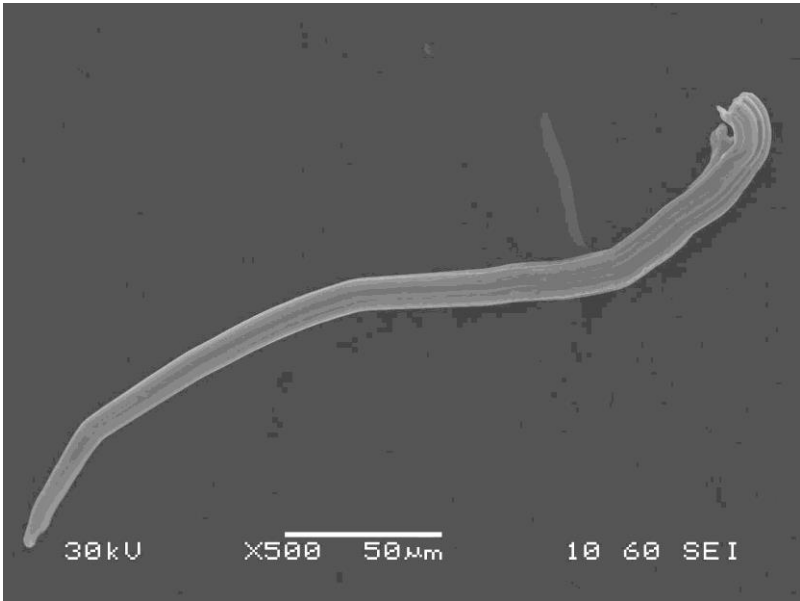
Figure 5: SEM view 01

Figure 6: SEM View 02

SEM analysis began with a general observation of the samples, taking a scientific look at the size, shape, and structure of the strands. At the nanoscale, the engineering team drew conclusions of the structure's origin based on the shape, form, and size of the observable features (Figures 5&6). Mechanical grooves were observable, and while there was a concern that these metal shavings were visually similar to tin whiskers, the size of the samples observed were not in the known size range of tin whiskers. EDS Analysis also allowed the team to conclude that the shavings were metallic in origin and could be causing intermittent shorts and signal losses across the pins of the connector.

Armed with the observations and conclusions provided by AAA Test Lab, the customer was able to move forward with a process correction to enable their product to be successful and fulfill its required operation.
